New Hampshire Volunteer Lake Assessment Program

2003 Interim Report for Great Pond Kingston

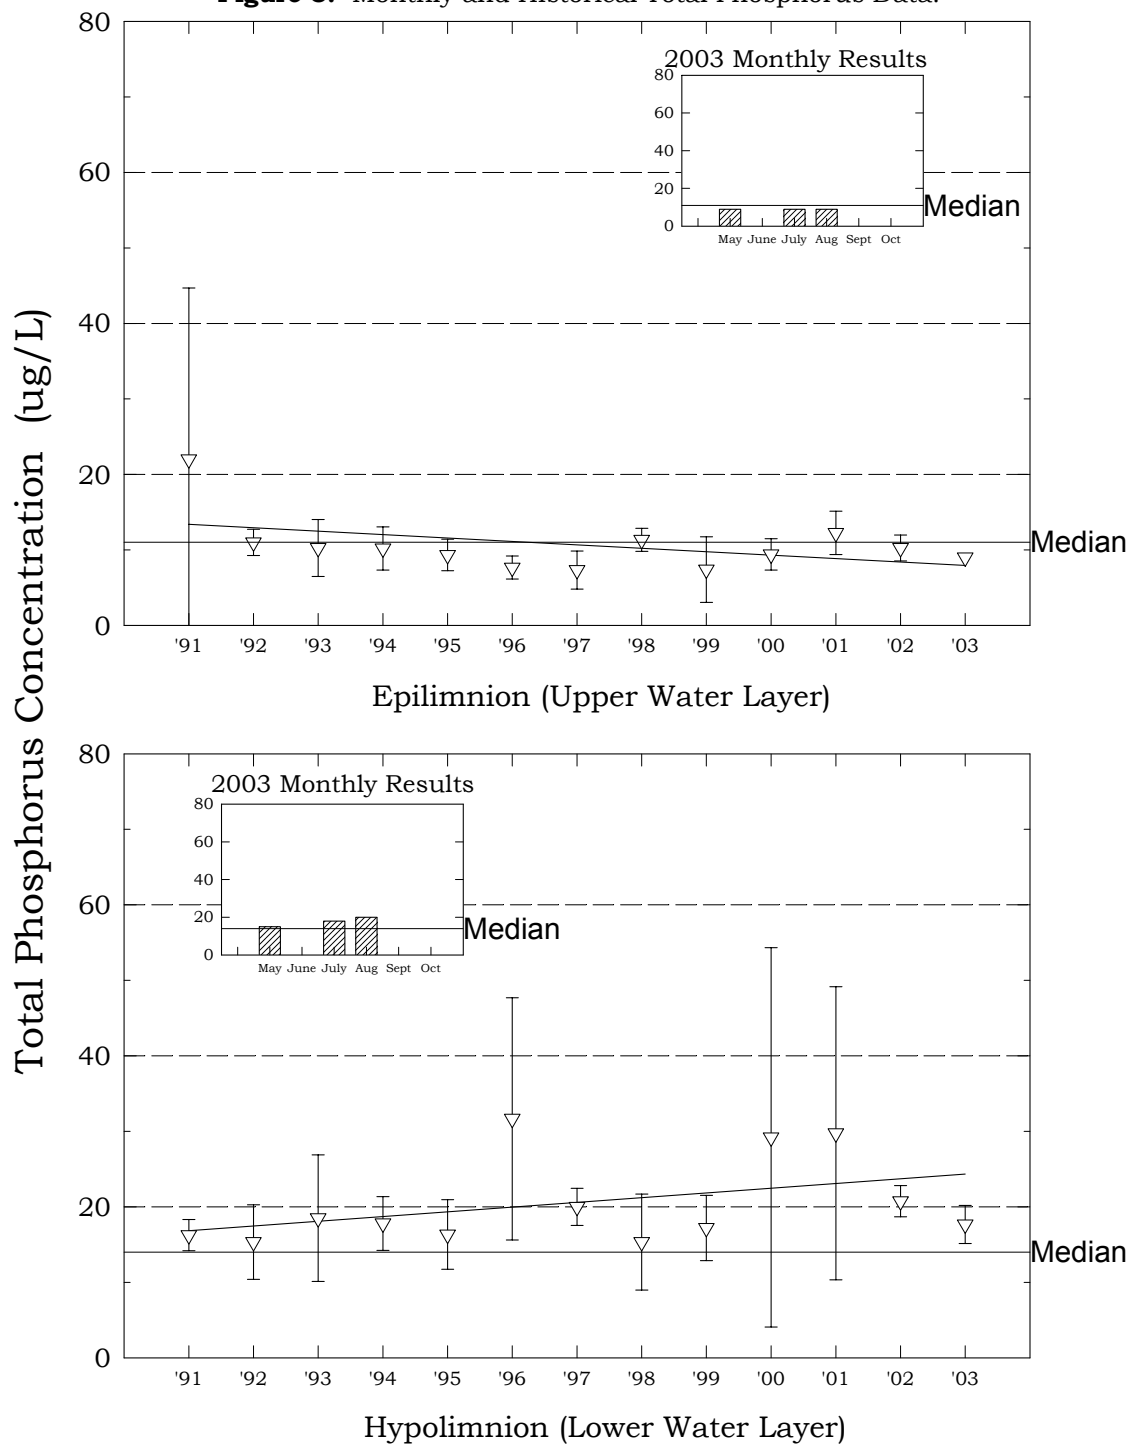
Figure 3. Monthly and Historical Total Phosphorus Data.

The current year data for the epilimnion (the top inset graph) show that the phosphorus concentration **remained relatively stable** from May to August. The phosphorus concentration on each sampling event was **slightly less than** the state median.

Overall, visual inspection of the historical data trend line for the epilimnion shows a **relatively stable** phosphorus trend since 1992. (Please note that the epilimnetic phosphorus concentration in 1991 was elevated.)

The current year data for the hypolimnion (the bottom inset graph) show that the phosphorus concentration **increased gradually** from May to July and from July to August. The phosphorus concentration on each sampling event was **greater than** the state median.

The historical data show that the 2003 mean hypolimnetic phosphorus concentration is **slightly greater than** the state median.

Overall, visual inspection of the historical data trend line for the hypolimnion shows an **increasing (meaning worsening)** phosphorus trend since monitoring began in 1991.

It is also important to point out that the phosphorus concentration in the hypolimnion at the North and South deep spot has typically been **greater than** the phosphorus concentration in the epilimnion. This data indicates that **internal phosphorus loading** is occurring in the hypolimnion. (Please refer to the discussion of Table 9 and 10 for a detailed explanation of internal total phosphorus loading.)

One of the most important approaches to reducing phosphorus loading to a waterbody is to continually educate watershed residents about its sources and how excessive amounts can adversely impact the ecology and value of lakes and ponds. Phosphorus sources within a lake or pond's watershed typically include septic systems, animal waste, lawn fertilizer, road and construction erosion, and natural wetlands.
